Confidential Property Report

A.C.C.S. PROPERTY INSPECTIONS

AGREEMENT NO: 2325
CLIENT Larsen, Mandy
PHONE:
EMAIL: Mandy.Larsen@ccrc.qld.gov.au
POSTAL ADDRESS:
PROPERTY: King Ranch Cultural Theatre
DATE: 24th October 2024
WEATHER: Fine

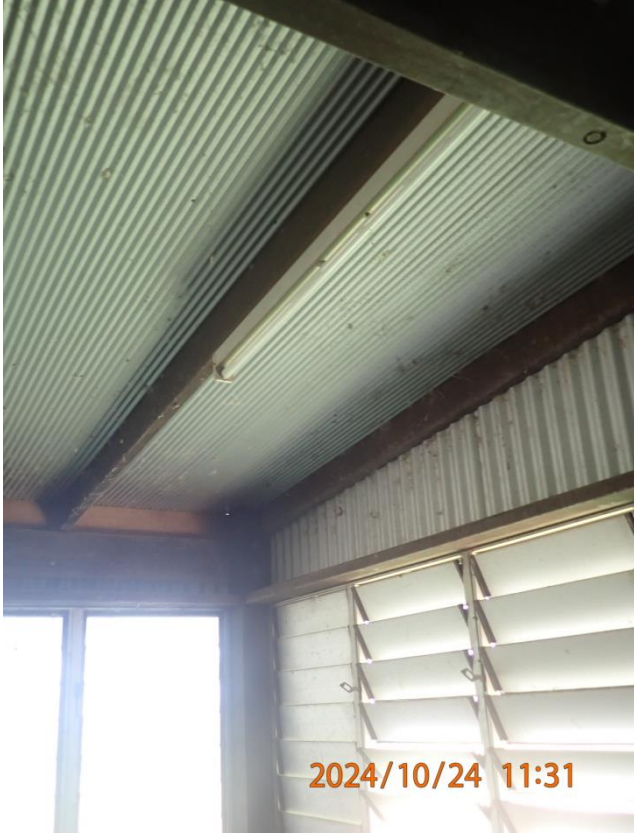
<ul style="list-style-type: none"> • In an acceptable condition. With cleaning of walls recommend and cleaning of gutter from vegetation growing. Building is not vermin proof. Roller door were not operated due to gear laying on doors

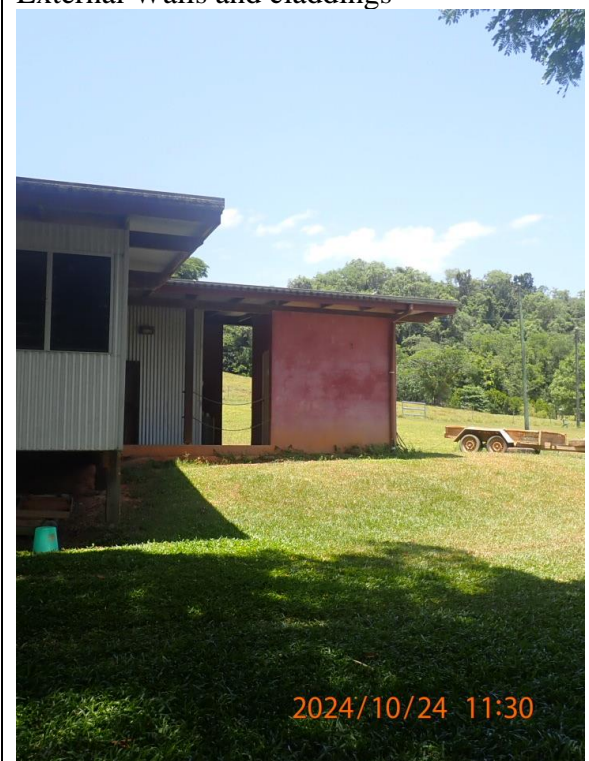
External Walls and claddings

Timber deterioration to gable ends and repairs are recommended. **Recommendation: Carpenter** – engage a suitably qualified carpenter for rectification advice in accordance with A1684.2

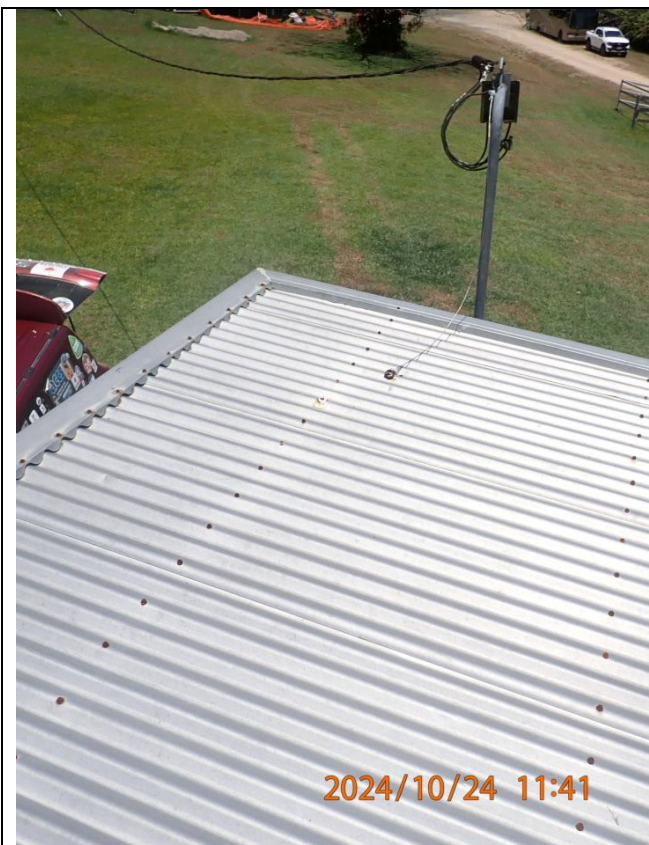
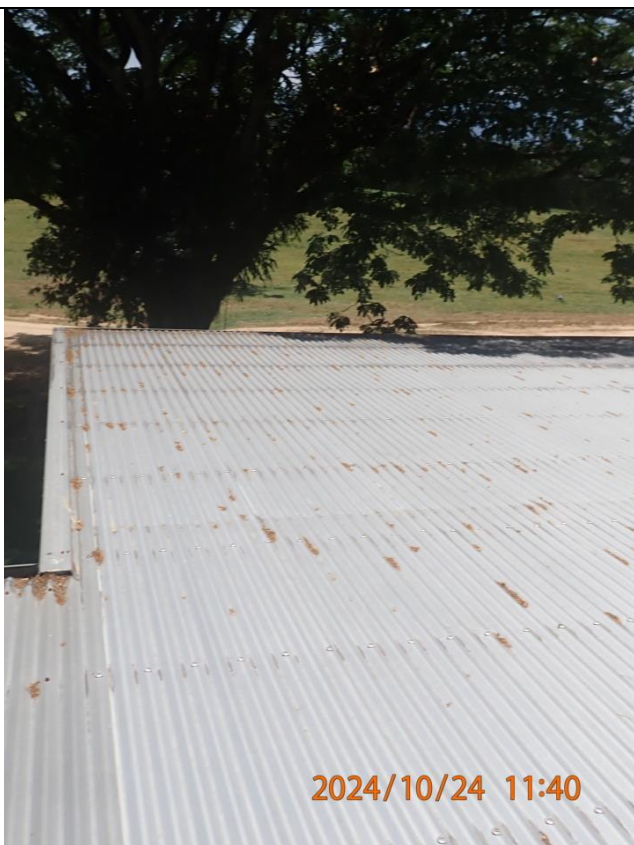
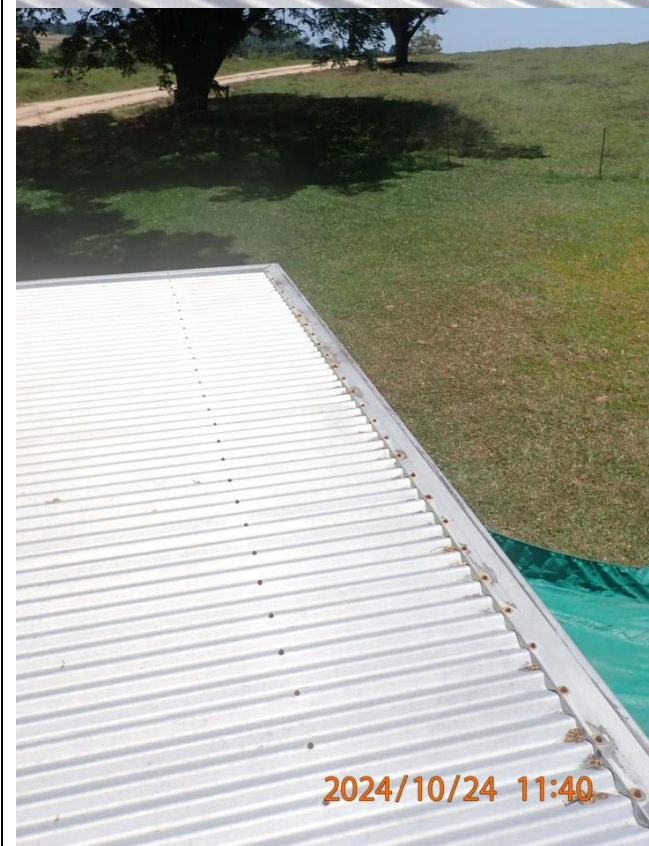
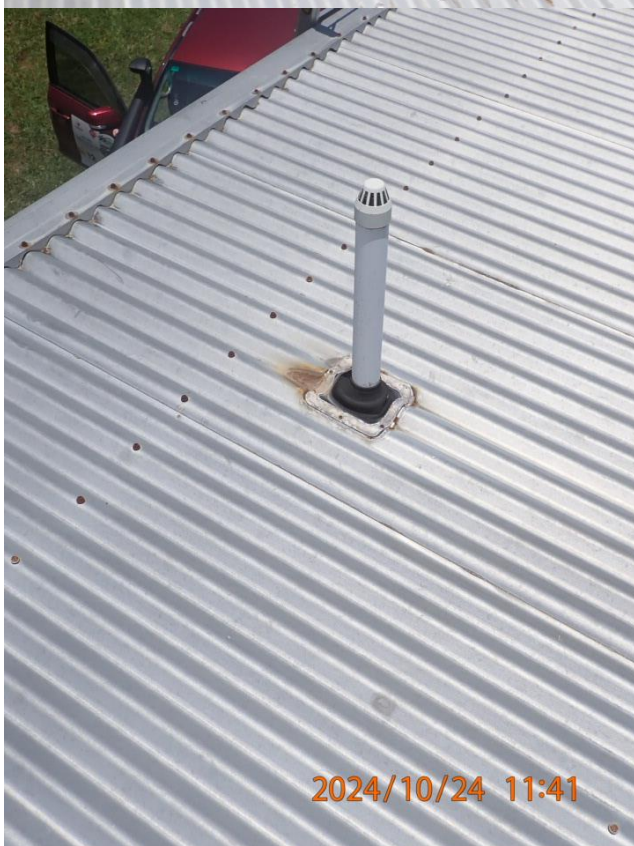
- **Defect:** minor rusting fixings and around vent pipe. clean roof sheeting of leaves
- **Location:** total roof area
- **Recommendation:** **Plumber** – Engage a suitably qualified plumber to provide rectification advice in accordance with AS/NZ 3500

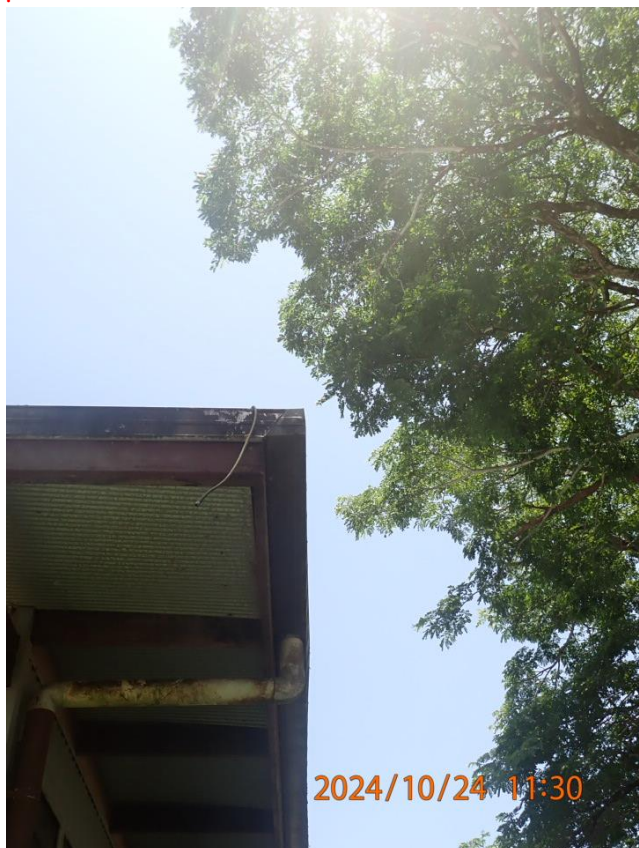
Fascia's, Soffits, Eaves

- Defect: minor deterioration
- Location: all
- Recommendation: **Plumber** – Engage a suitably qualified plumber to provide rectification advice in accordance with AS/NZ 3500
- Recommendation: **Carpenter** – engage a suitably qualified carpenter for rectification advice in accordance with A1684.2

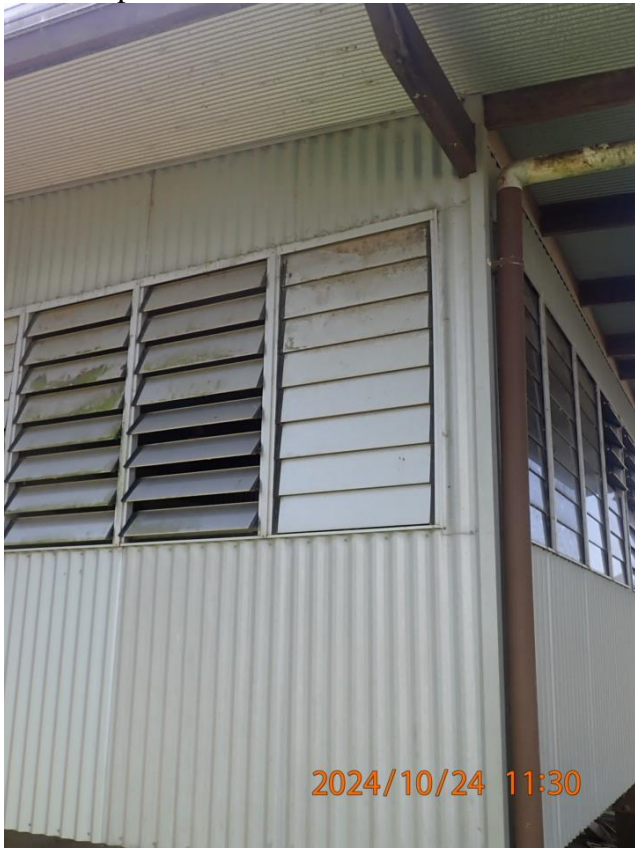
Down Pipes

- Defect: minor repairs required
- Location: all
- Recommendation: **Plumber** – Engage a suitably qualified plumber to provide rectification advice in accordance with AS/NZ 3500

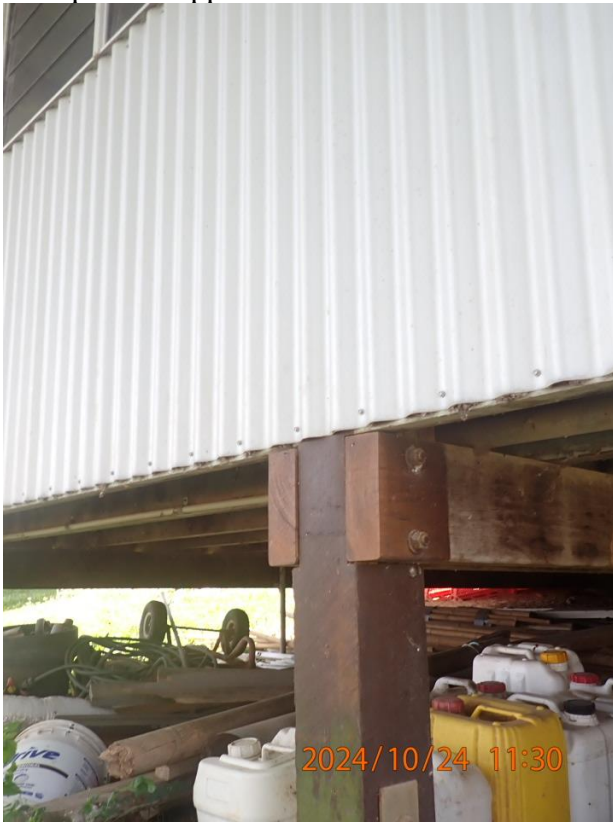
Stumps and support

- Minor Deteriorating to several timber supports and repairs are recommended.

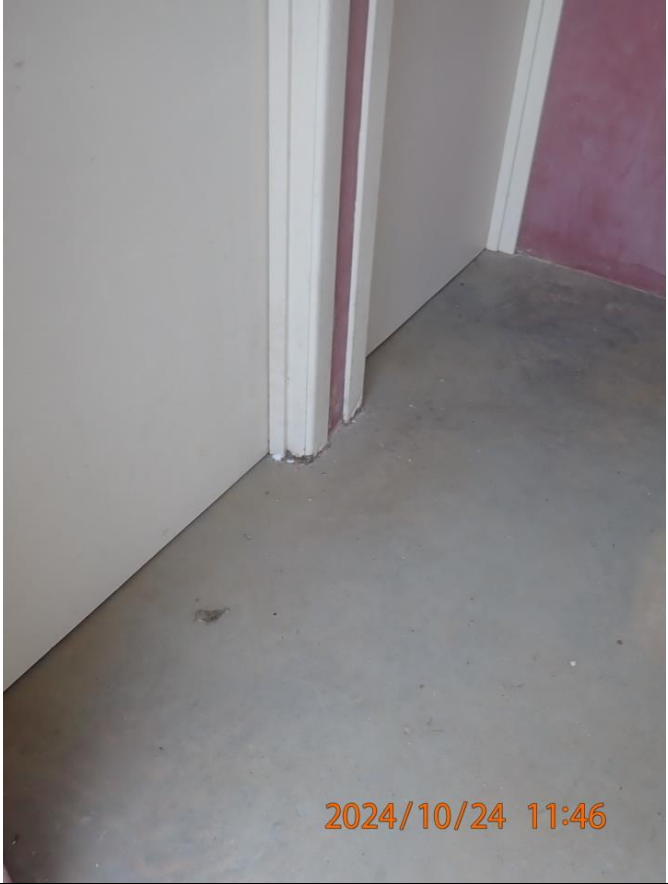
<ul style="list-style-type: none"> • Visible cracking to concrete
<p>Doors</p> <p>Recommend rekeying or replacing all external door locks upon purchase reason being as all keys may not have worked correctly.</p>	<ul style="list-style-type: none"> • Defect: minor repairs recommended. • Recommendation: Carpenter – engage a suitably qualified carpenter for rectification advice in accordance with A1684.2

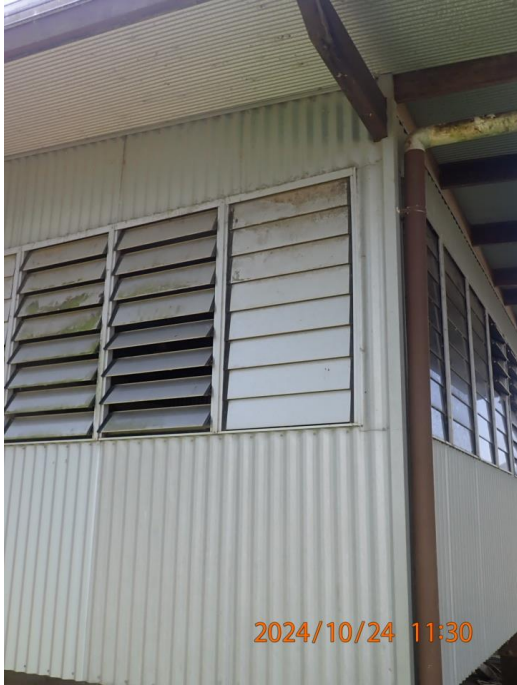
Window

- **Defect:** minor repairs recommended. Visible rust to louvers
- **Recommendation: Carpenter** – engage a suitably qualified carpenter for rectification advice in accordance with A1684.2

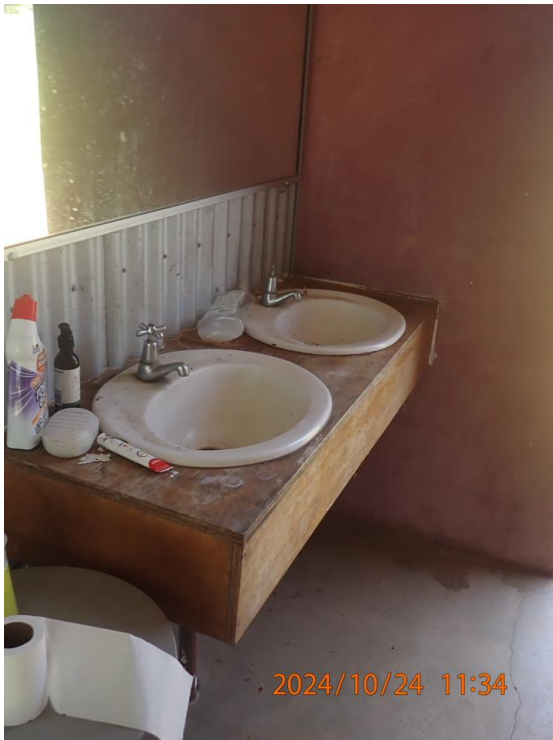
Bathroom 1 –

- In a fair condition with repairs recommended.
- Recommend replacement of all sealants as preventative maintenance when required.

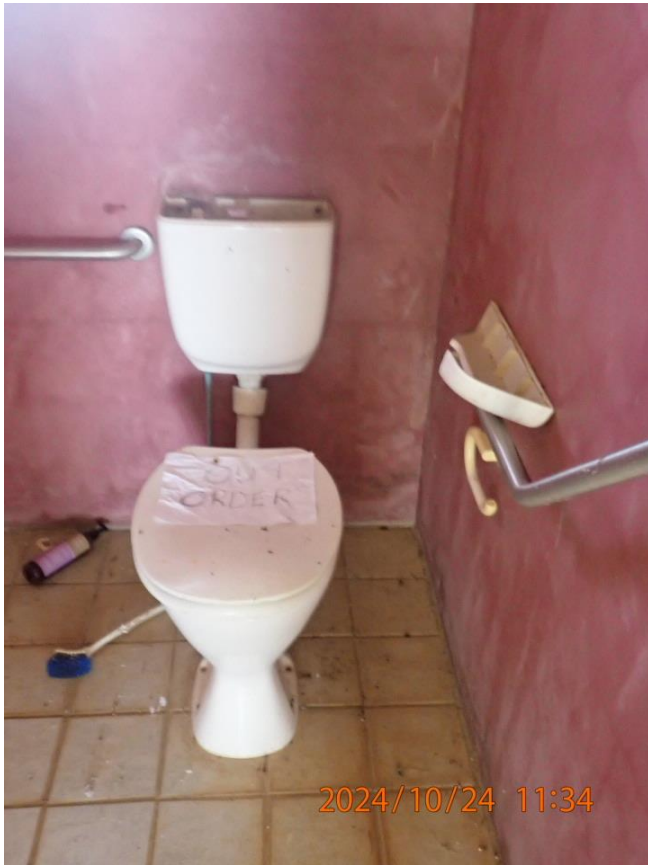
Toilets –

- Generally, appears to be in a fair condition. 1 is not working
- Recommend replacement of all sealants as preventative maintenance when required.
