Confidential Property Report

A.C.C.S. PROPERTY INSPECTIONS

AGREEMENT NO: 2325
CLIENT Larsen, Mandy
PHONE:
EMAIL: Mandy.Larsen@ccrc.qld.gov.au
POSTAL ADDRESS:
PROPERTY: King Ranch Cultural Theatre
DATE: 24th October 2024
WEATHER: Fine

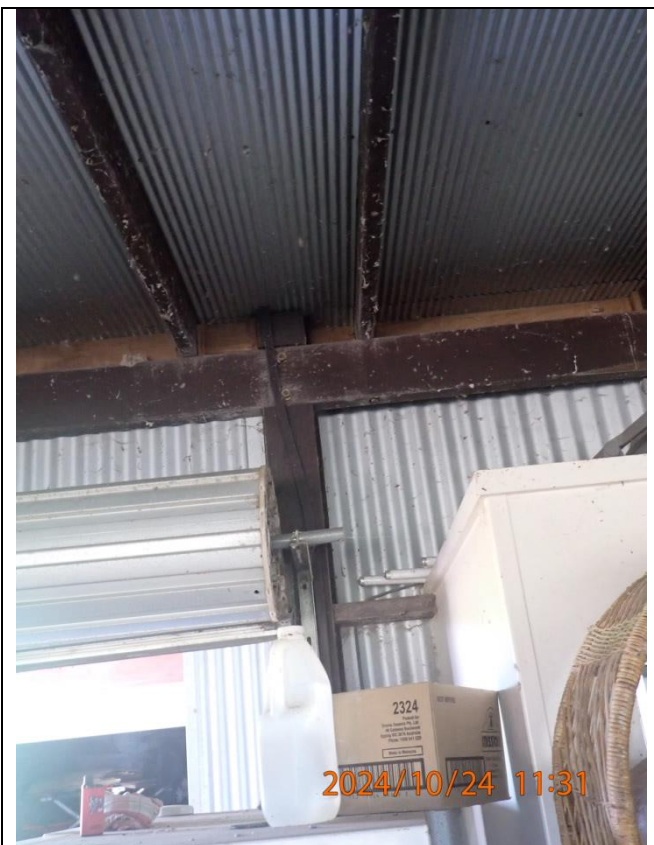
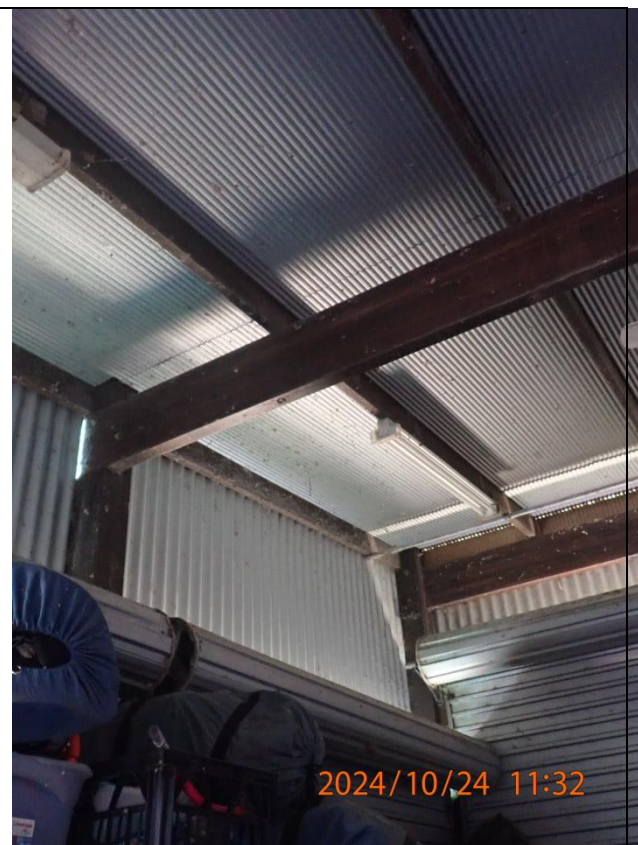
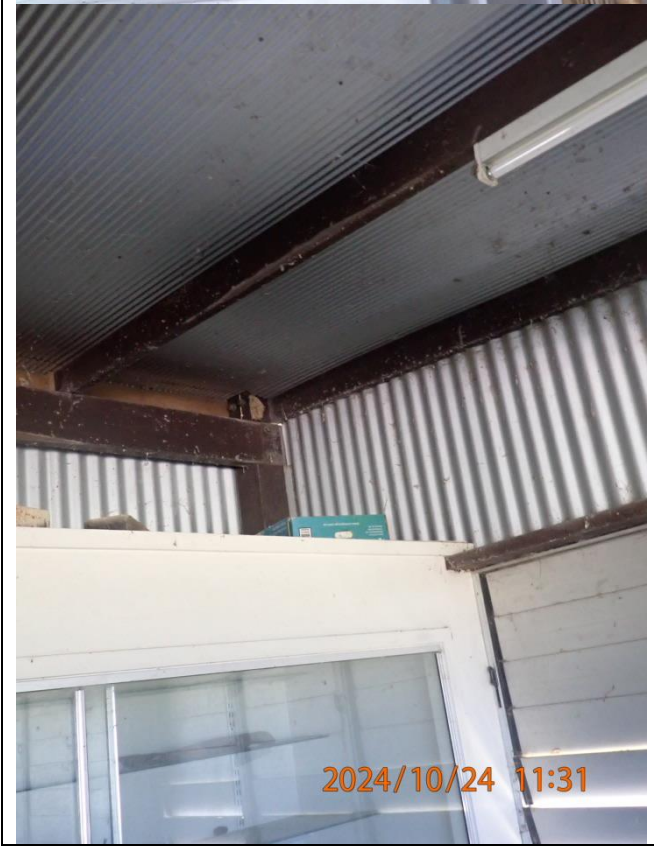
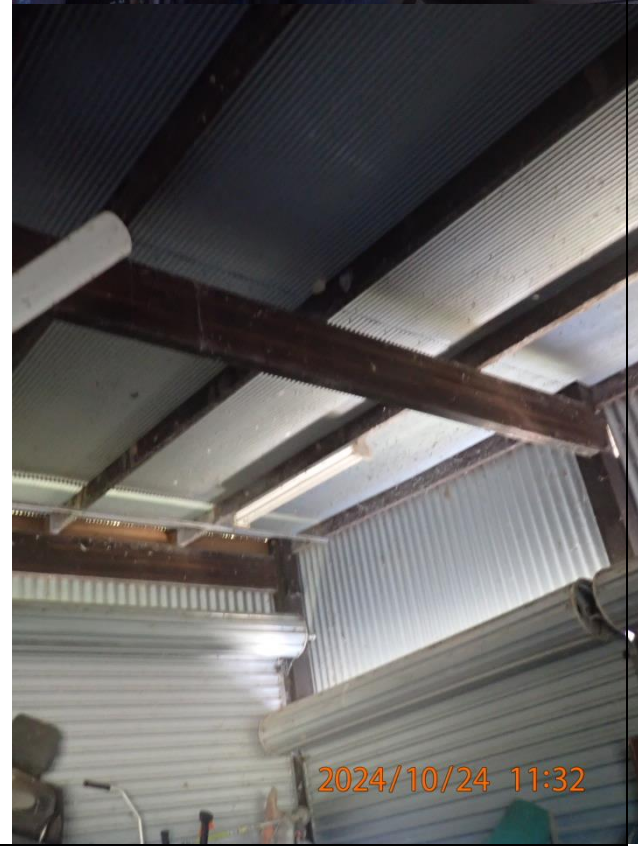
<ul style="list-style-type: none"> • In an acceptable condition. With cleaning of walls recommend and cleaning of gutter from vegetation growing. Building is not vermin proof. Roller door were not operated due to gear laying on doors

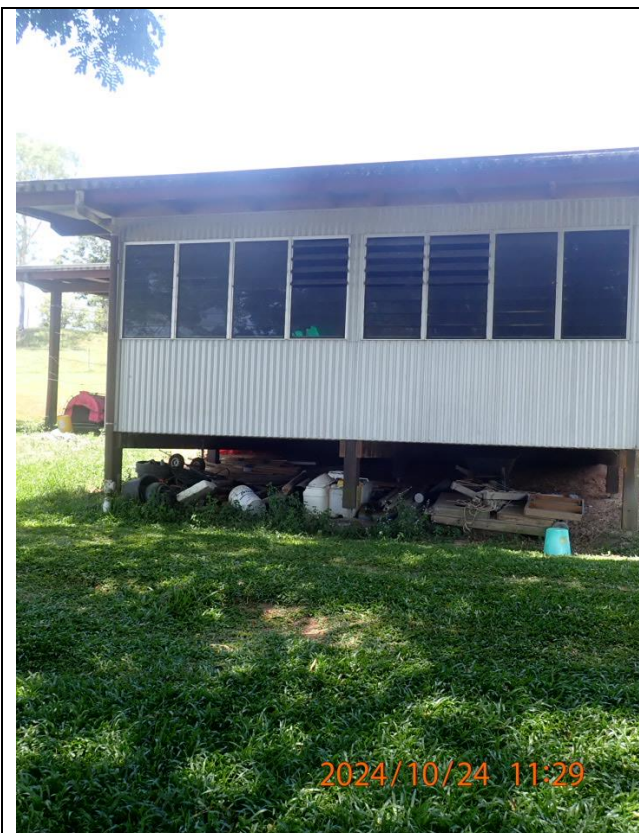
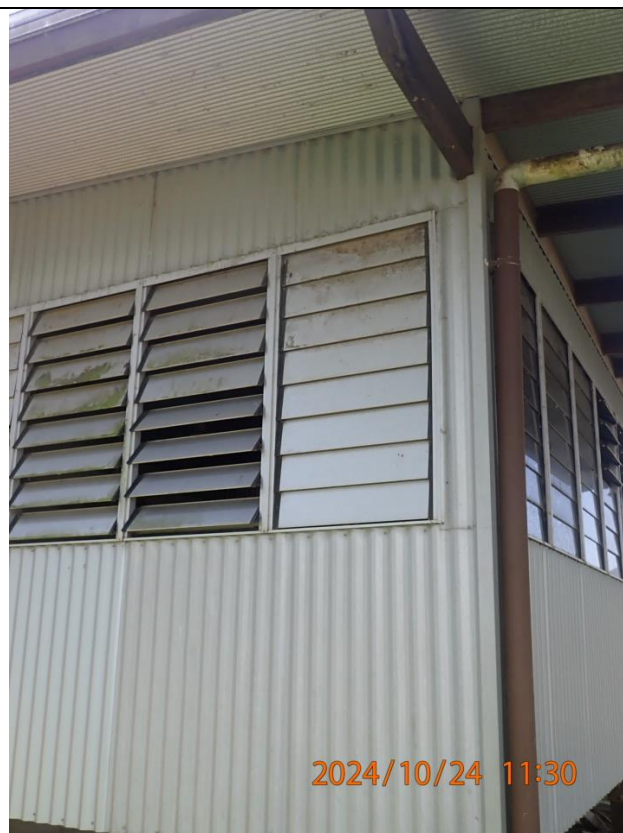
Timber deterioration to gable ends and repairs are recommended. **Recommendation: Carpenter** – engage a suitably qualified carpenter for rectification advice in accordance with A1684.2

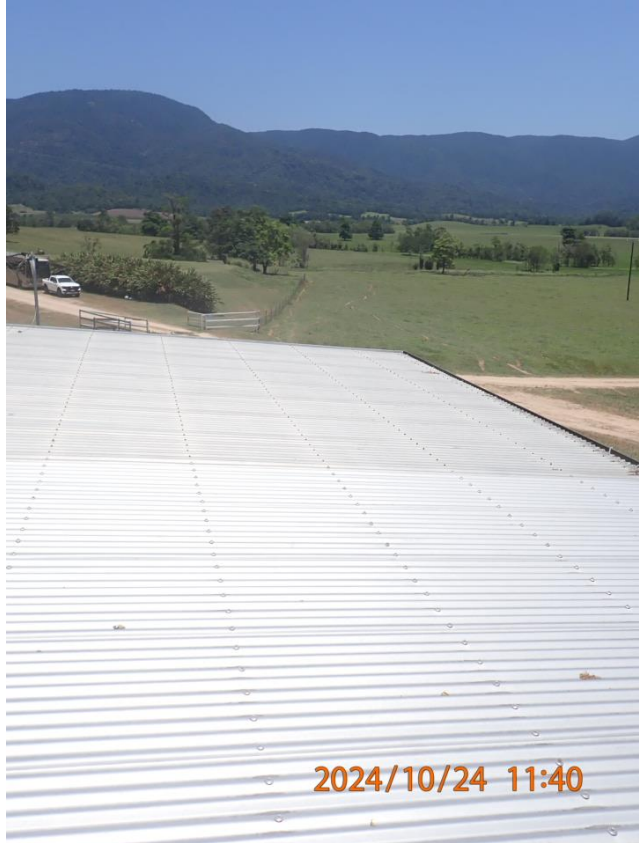
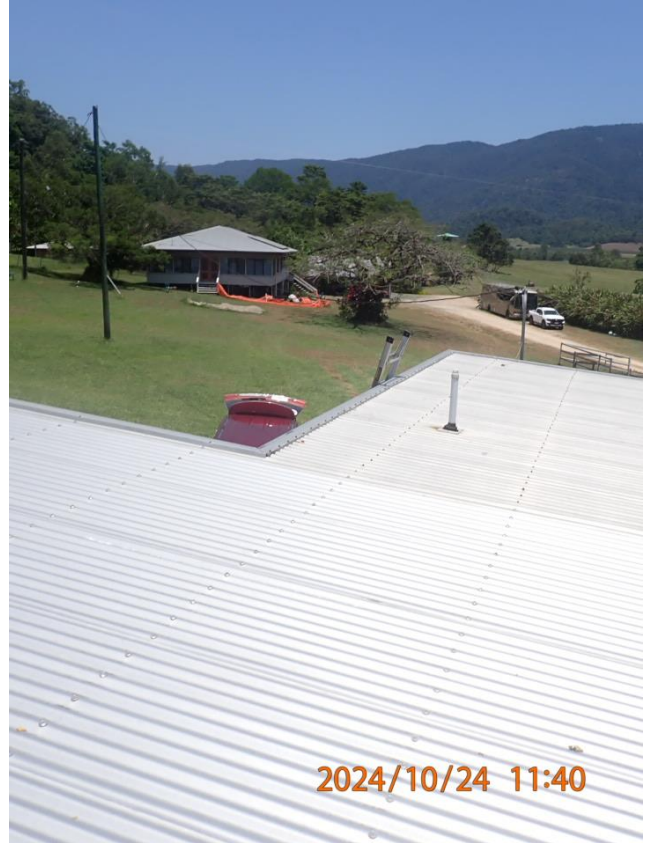
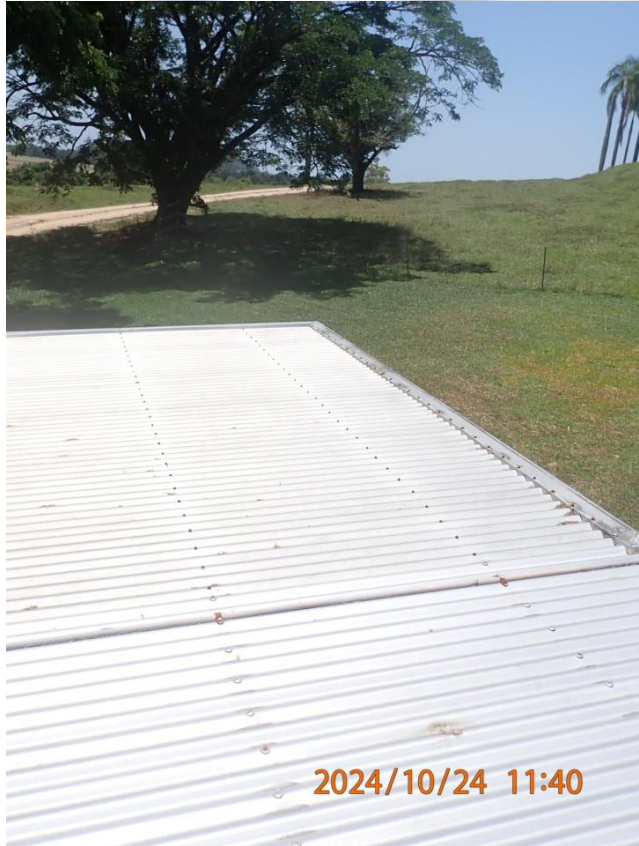
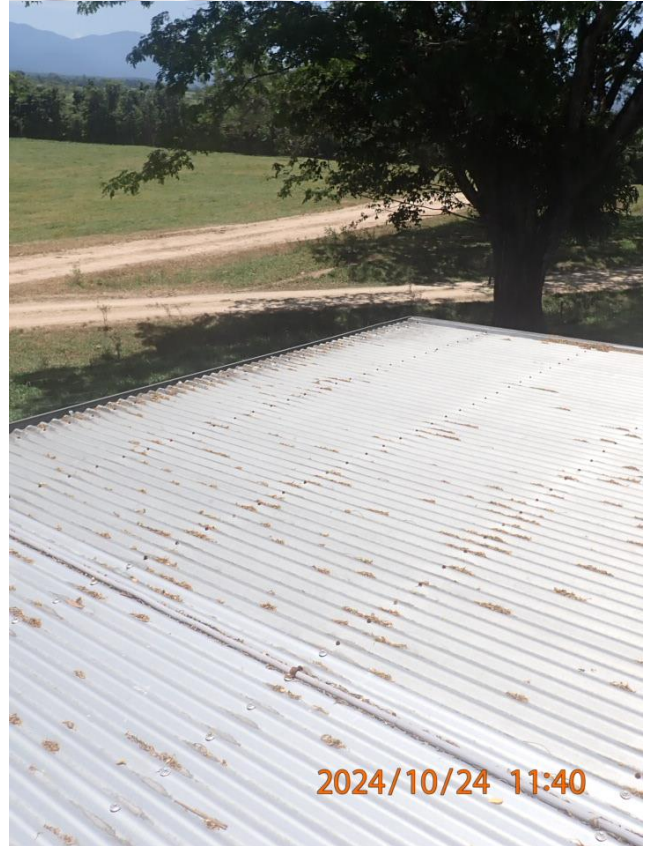
- **Defect:** minor rusting fixings and around vent pipe. clean roof sheeting of leaves
- **Location:** total roof area
- **Recommendation:** **Plumber** – Engage a suitably qualified plumber to provide rectification advice in accordance with AS/NZ 3500

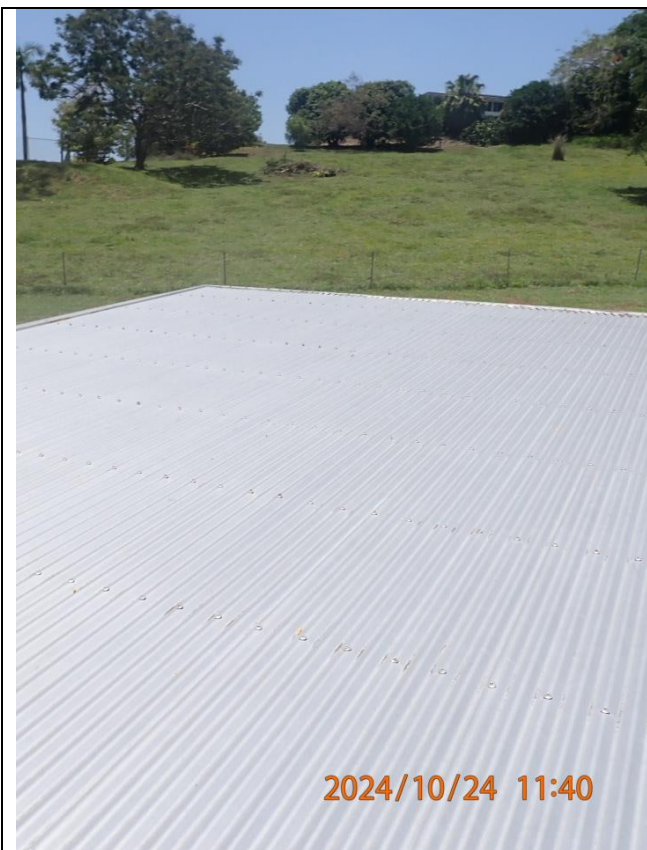
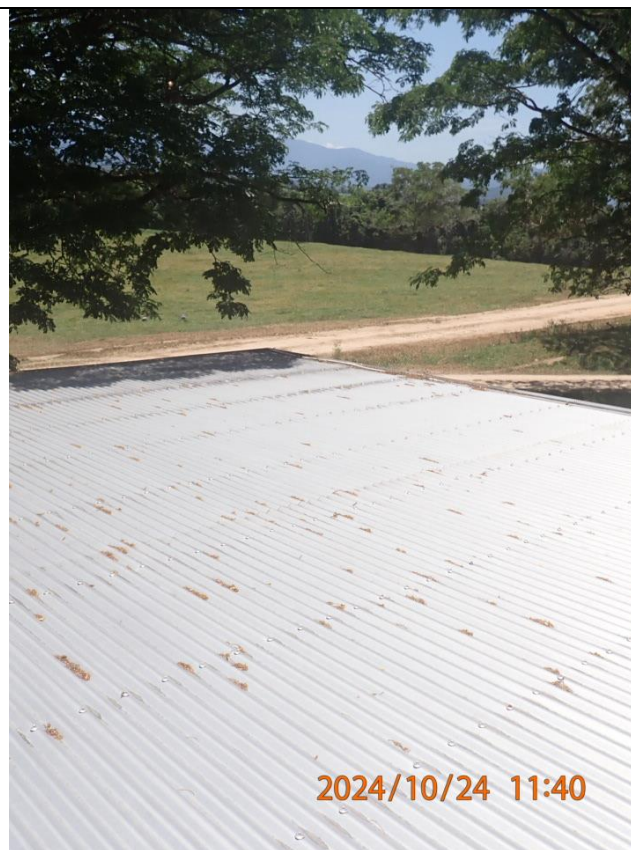
- Defect: rust to fixings
- Location: all
- Recommendation: **Plumber** – Engage a suitably qualified plumber to provide rectification advice in accordance with AS/NZ 3500

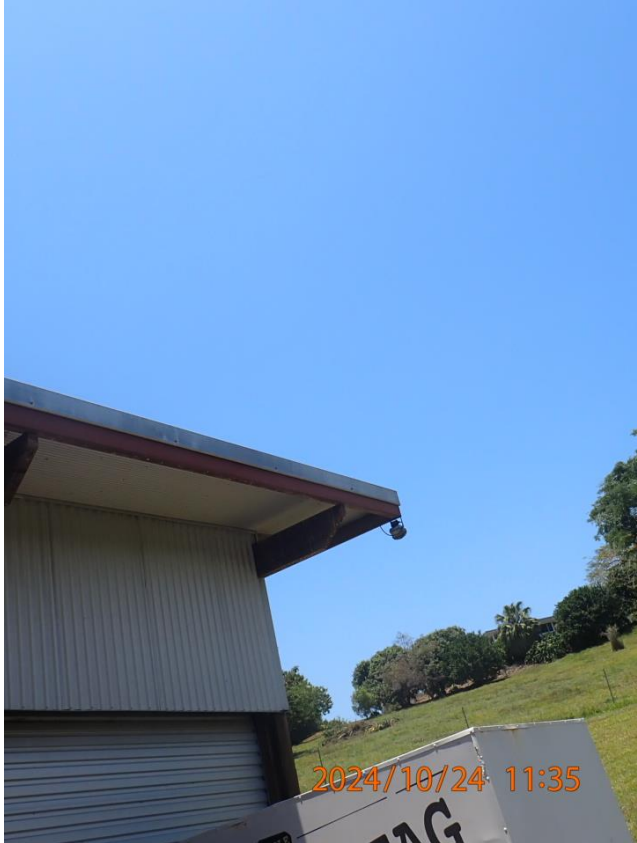
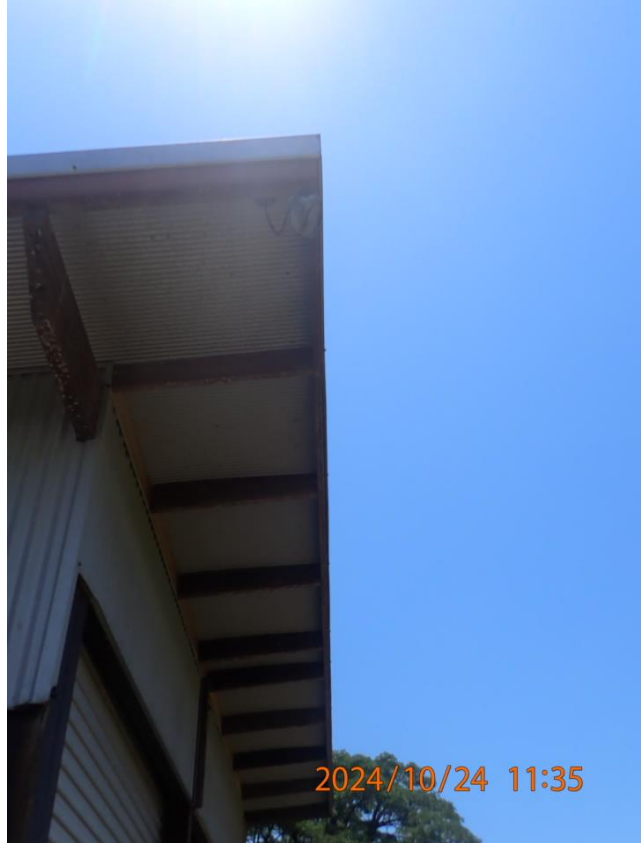
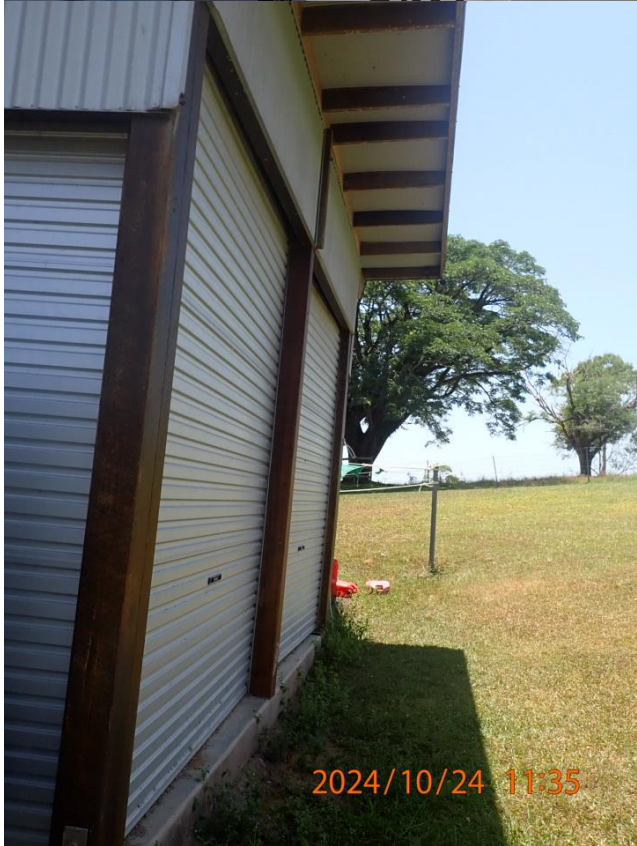
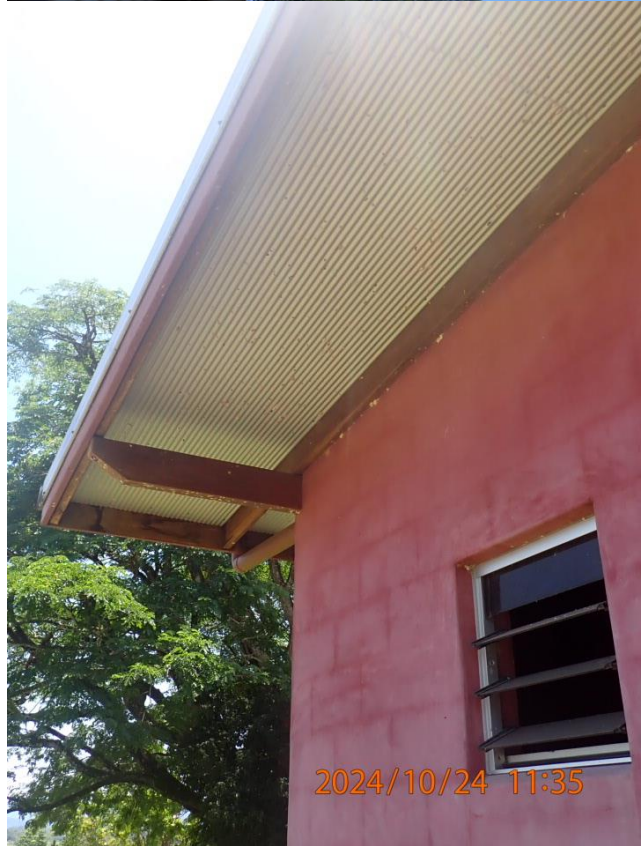
- Defect: minor deterioration
- Location: all
- Recommendation: **Plumber** – Engage a suitably qualified plumber to provide rectification advice in accordance with AS/NZ 3500
- Recommendation: **Carpenter** – engage a suitably qualified carpenter for rectification advice in accordance with A1684.2

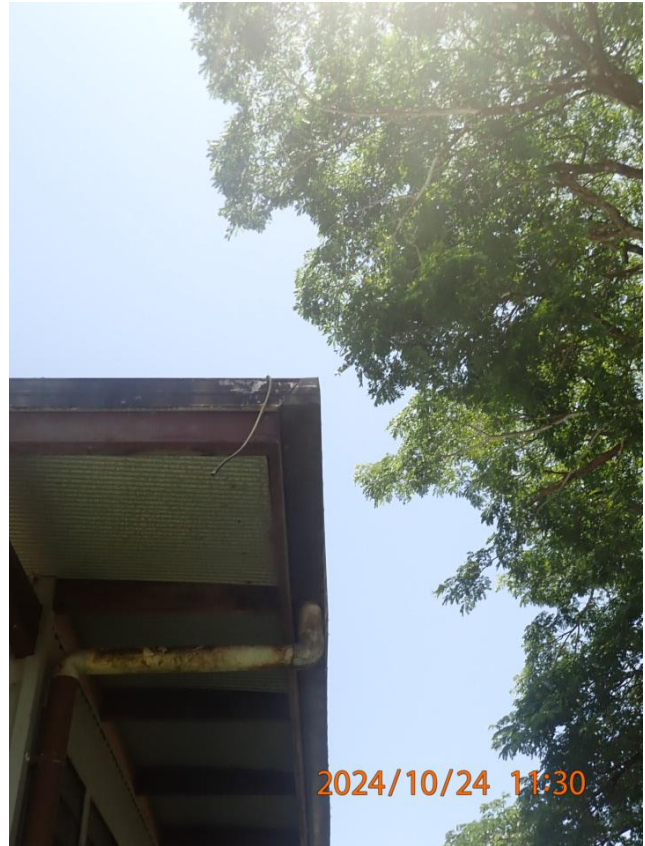
- Defect: minor repairs required
- Location: all
- Recommendation: **Plumber** – Engage a suitably qualified plumber to provide rectification advice in accordance with AS/NZ 3500

Under floor Areas	Comments
Tie Downs and metal items. <i>Recommend all bare metal items are treated and coated with a rust preventative</i>	<ul style="list-style-type: none"> • Visible rust to hold down bolts.
Termite Barriers (Any Caps etc.)	<p>Timber And Pest – Seek advice from qualified and experienced professional in accordance with AS 3660.</p>

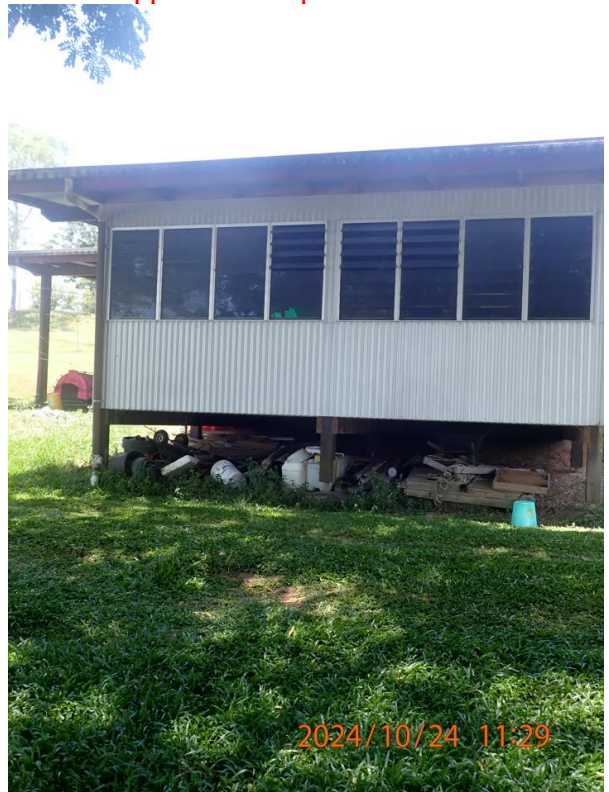
- Minor Deteriorating to several timber supports and repairs are recommended.

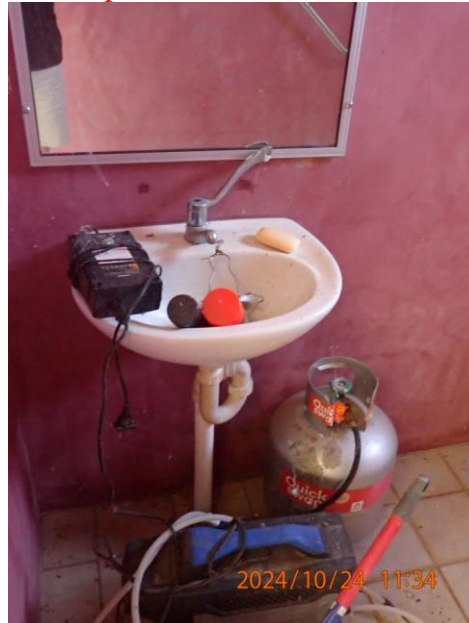
- In a fair condition with repairs recommended.
- Recommend replacement of all sealants as preventative maintenance when required.

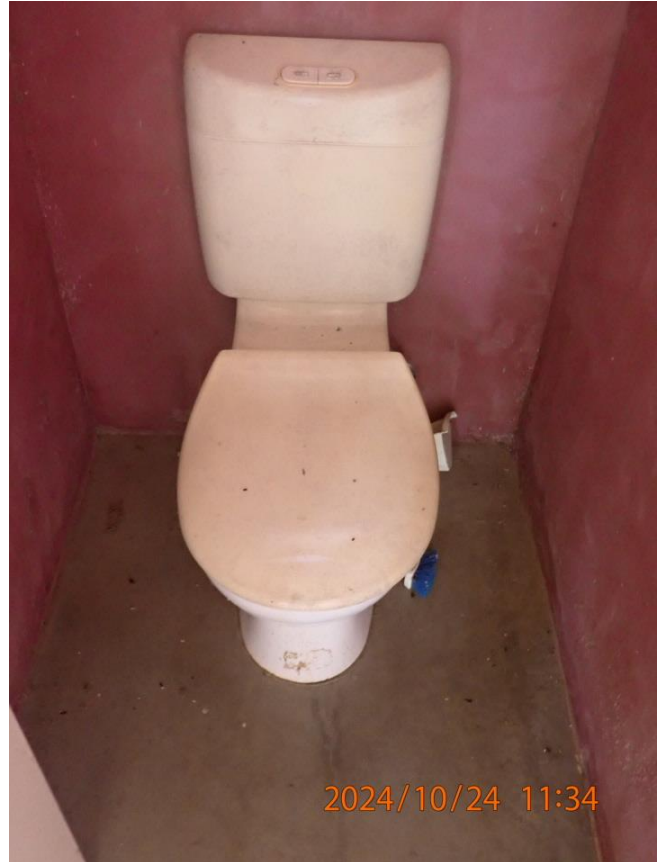
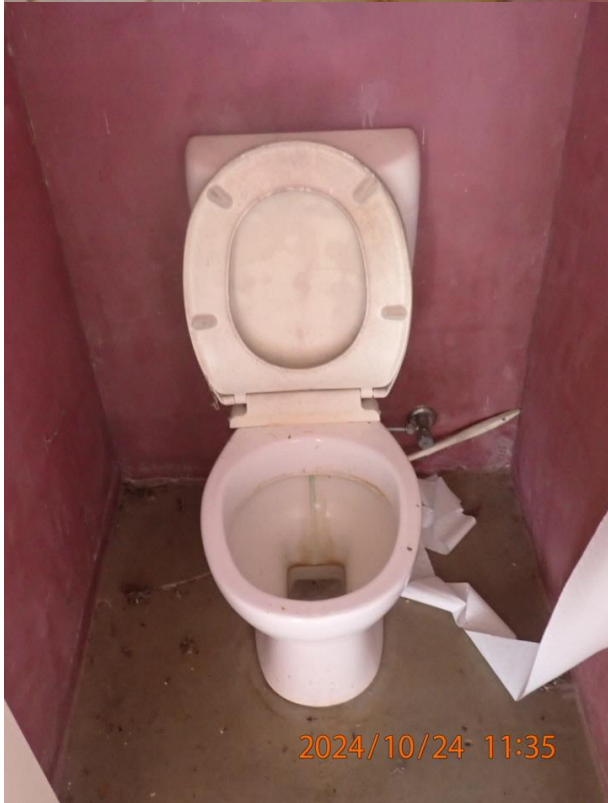
- Generally, appears to be in a fair condition. 1 is not working
- Recommend replacement of all sealants as preventative maintenance when required.
